Supplementary material

APPENDIX 1

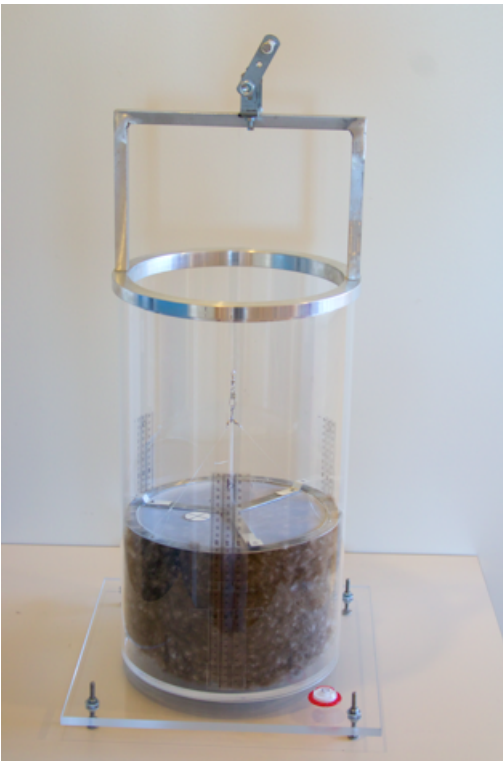
Figure A2. Custom-made, piston-cylinder device (Skipavík, Stykkishólmur, Iceland) to measure fill power of down samples.

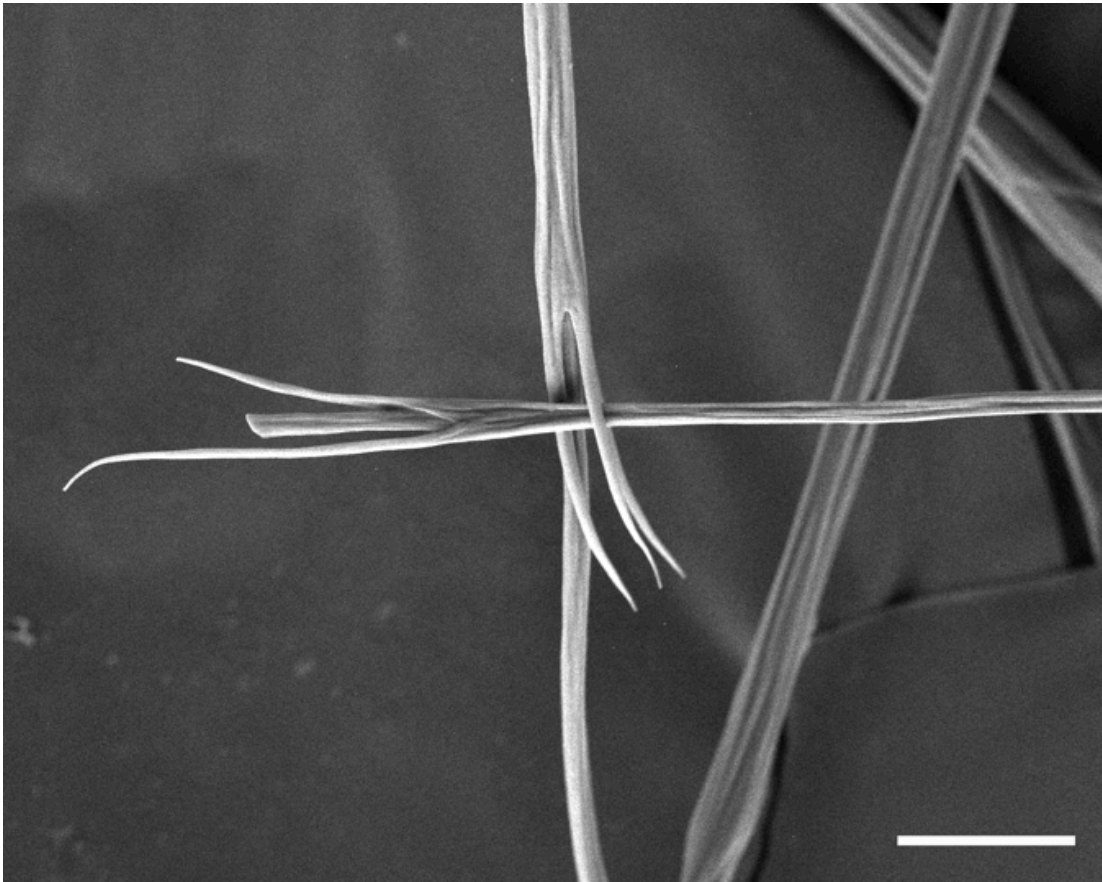
Figure A4. Scanning electron micrograph of Common Eider (*Somateria mollissima*) plumule barbules showing pronged nodes interlocking 2 barbules together. Scale bar 10 μ m.
